Klamath National Forest Best Management Practices

REGION 5 EVALUATION PROGRAM WATER QUALITY MONITORING REPORT 2010 Fiscal Year

January 28, 2010

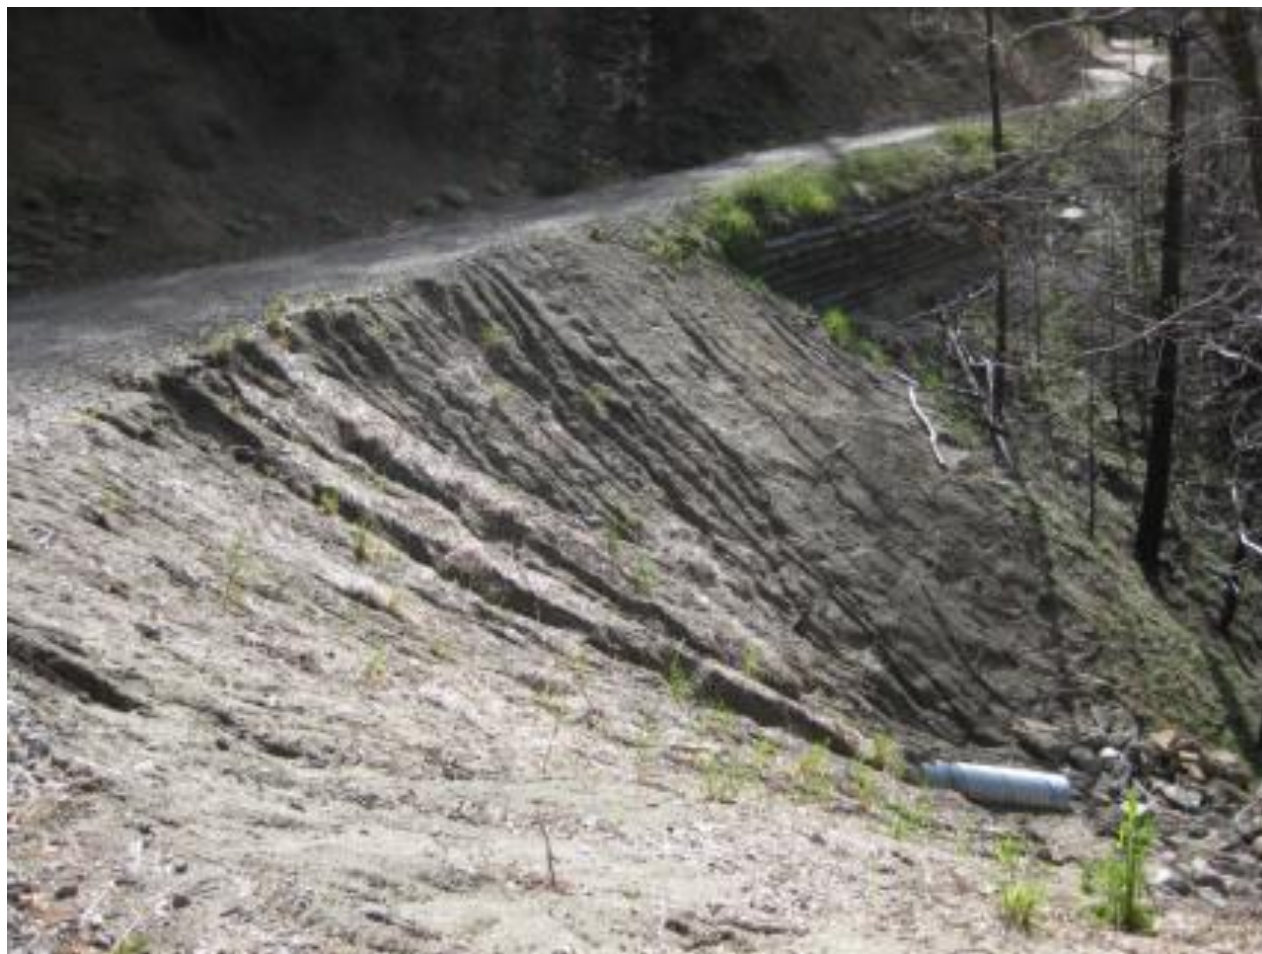
Though BMP requires were met, two out of four sites received a rating of “at-risk” for effectiveness failure. The issues that were identified resulted from a decomposed granitic fill slope that was not adequately mulched and/or armored. This led to numerous large rills and gullies which transport sediment to the outlet. This was identified as a possible oversight in the design of the crossing and/or contract requirements. A possible solution is better project design that accounts for sensitive soil types such as decomposed granitics and better Forest oversight of project implementation.

Figure 1. Rills and gullies on insufficiently protected decomposed granite fill slope on road # 15N06

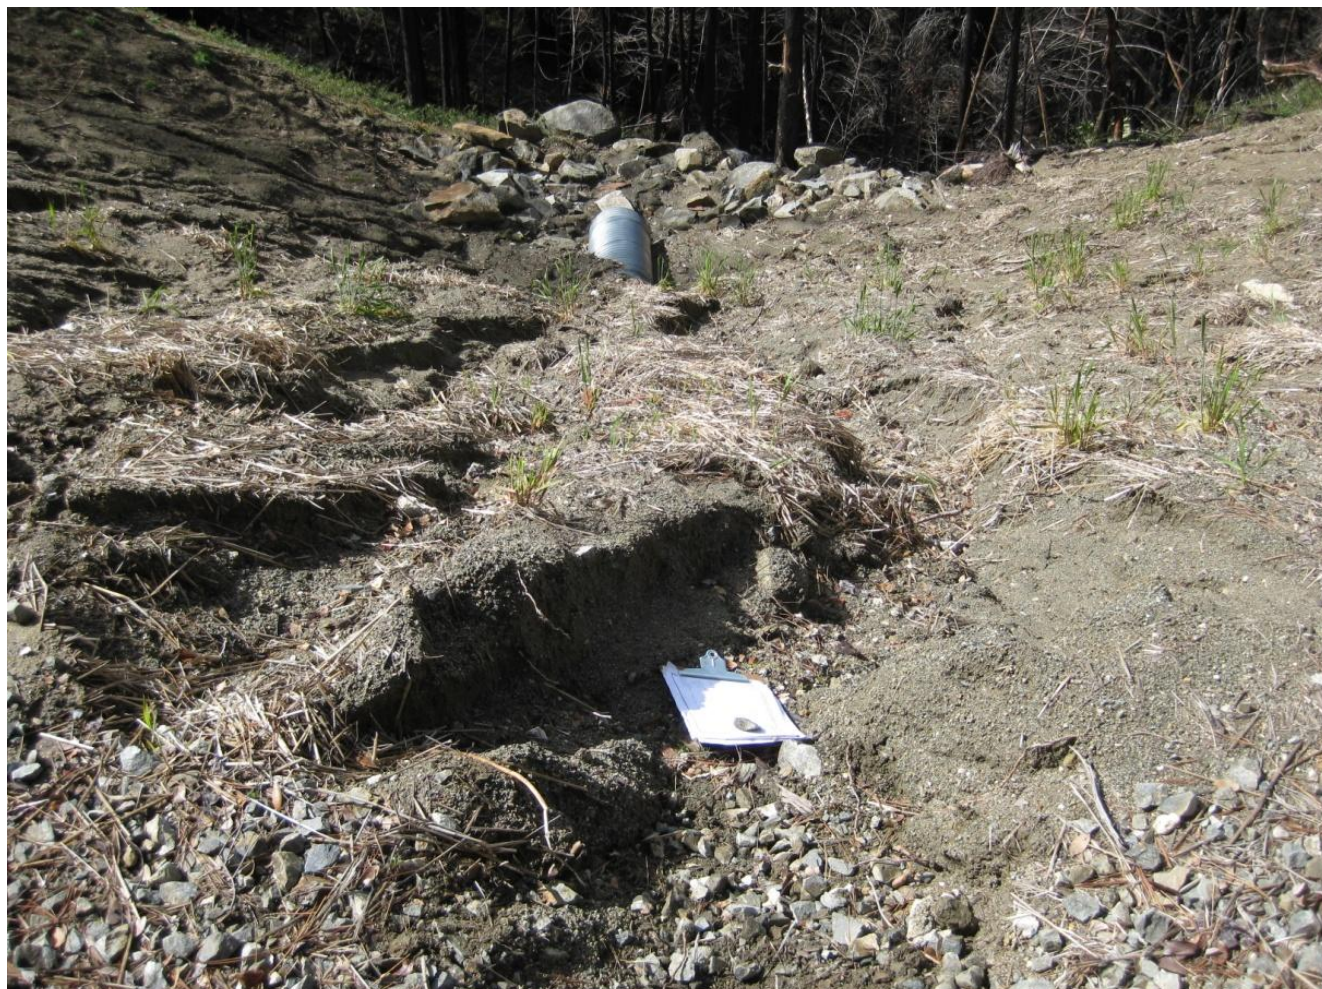
Figure 2. Gully with evidence of sediment delivery to channel on road #15N06

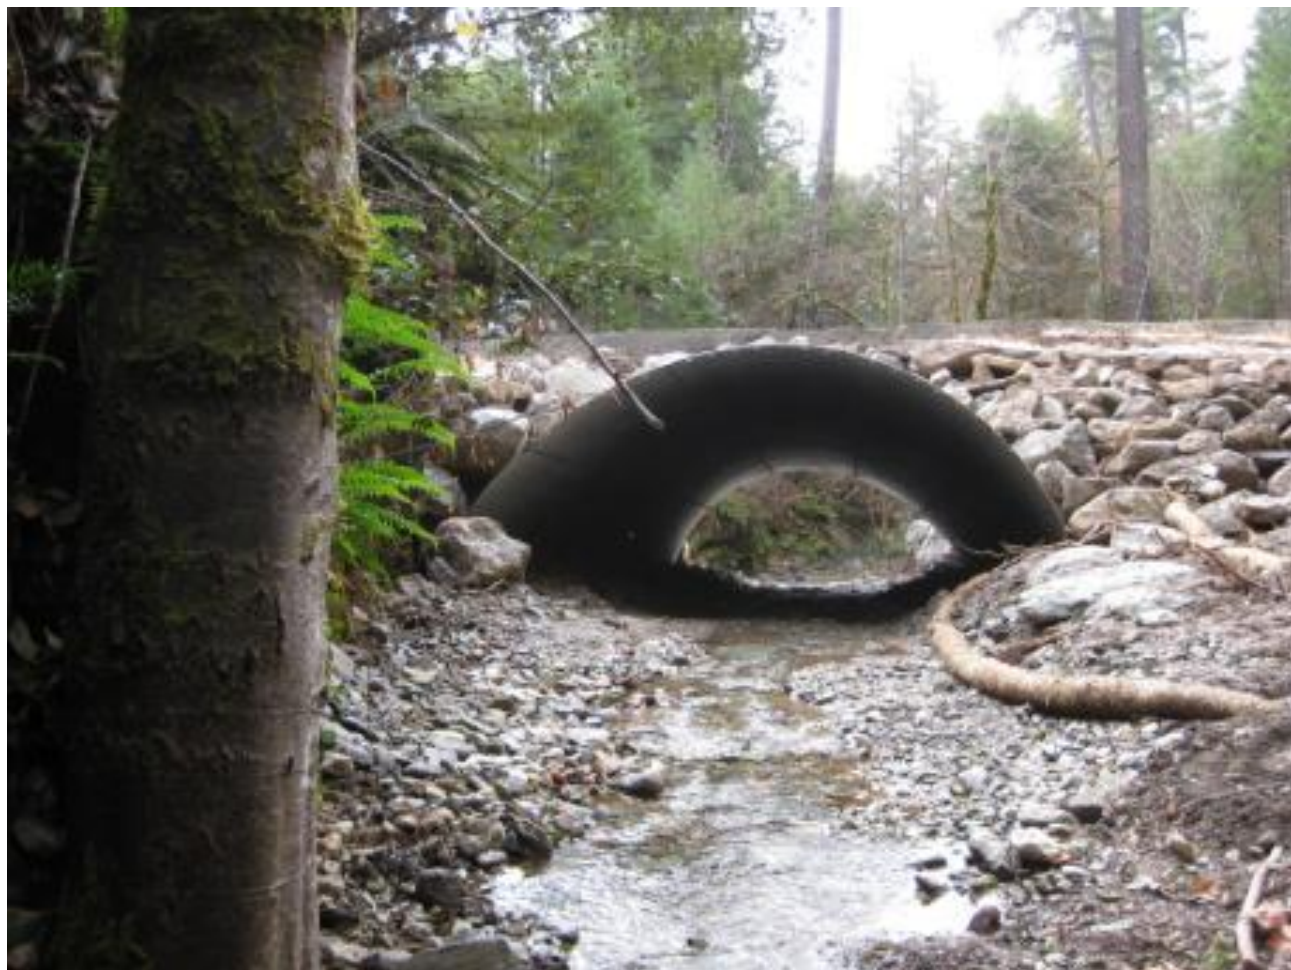
Figure 3. Completed culvert installation at the China Creek site.

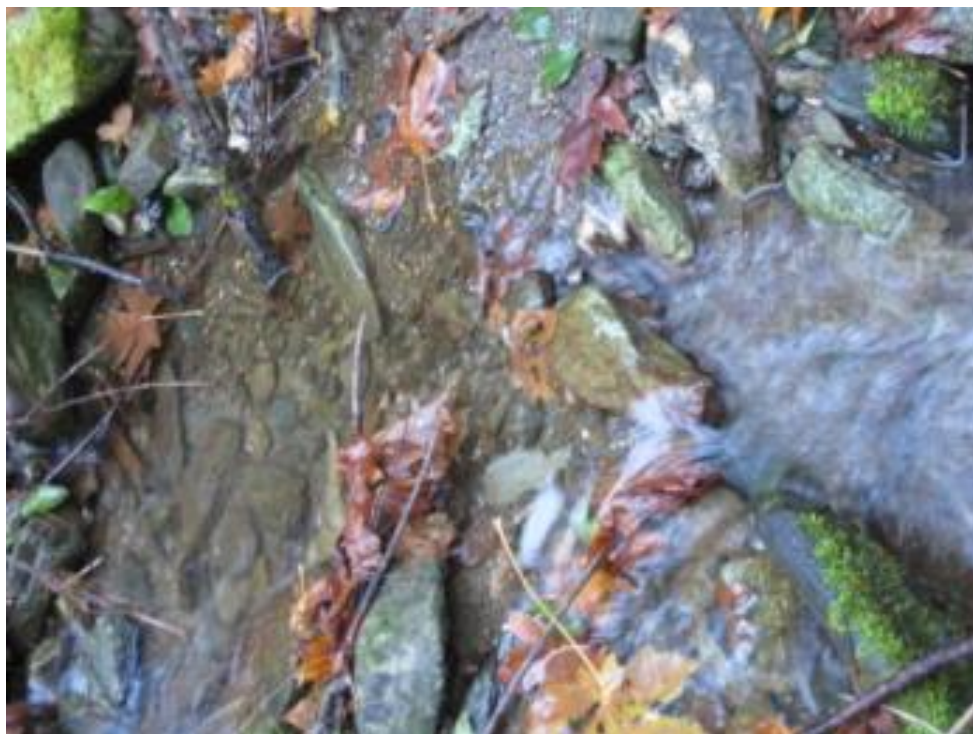
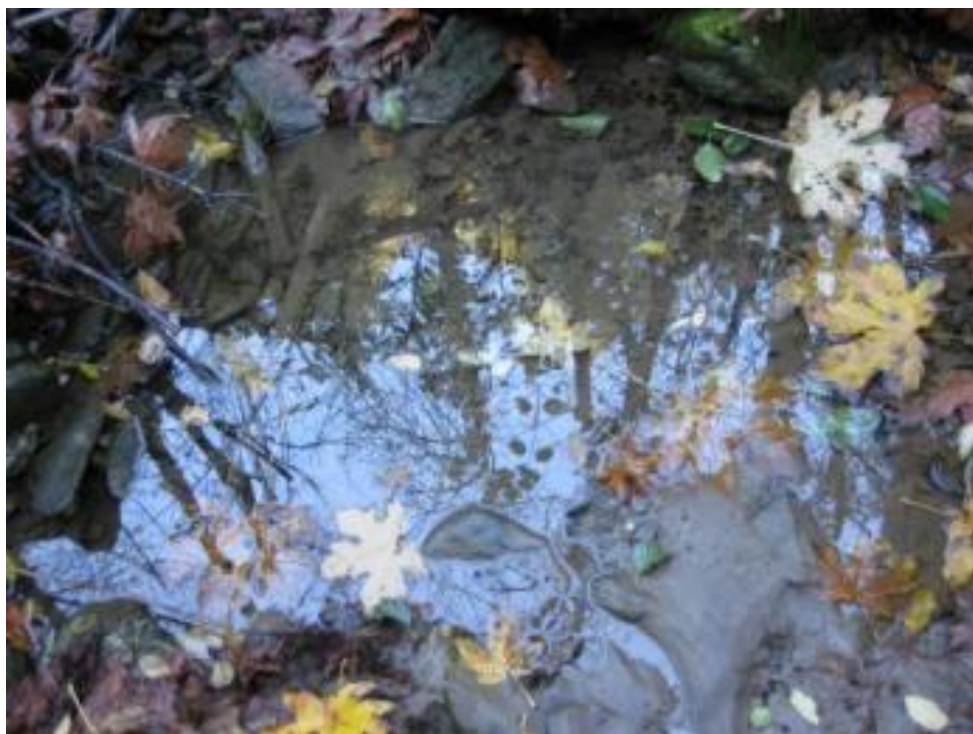
Figure 4a

Two out of three in-channel construction projects were rated as failing effectiveness in 2010. Two in-channel construction projects in the China-Fish Aquatic Passage experienced early winter storms in September and October during implementation. The Fish Gulch crossing was nearly finished during this large October event, but the China Creek crossing was still under construction. The Effectiveness evaluation for Active Project was not met for “sedimentation of channel riffle substrate” at both sites. The cause of the effectiveness failure is due to the fact that the contract was awarded later than expected and the contractor did not complete the project prior to the winter.

Riffle substrate composition on Fish Gulch upstream of construction site on top (4a) compared to downstream on the bottom (4b) shows a discernible difference in sediment deposition.

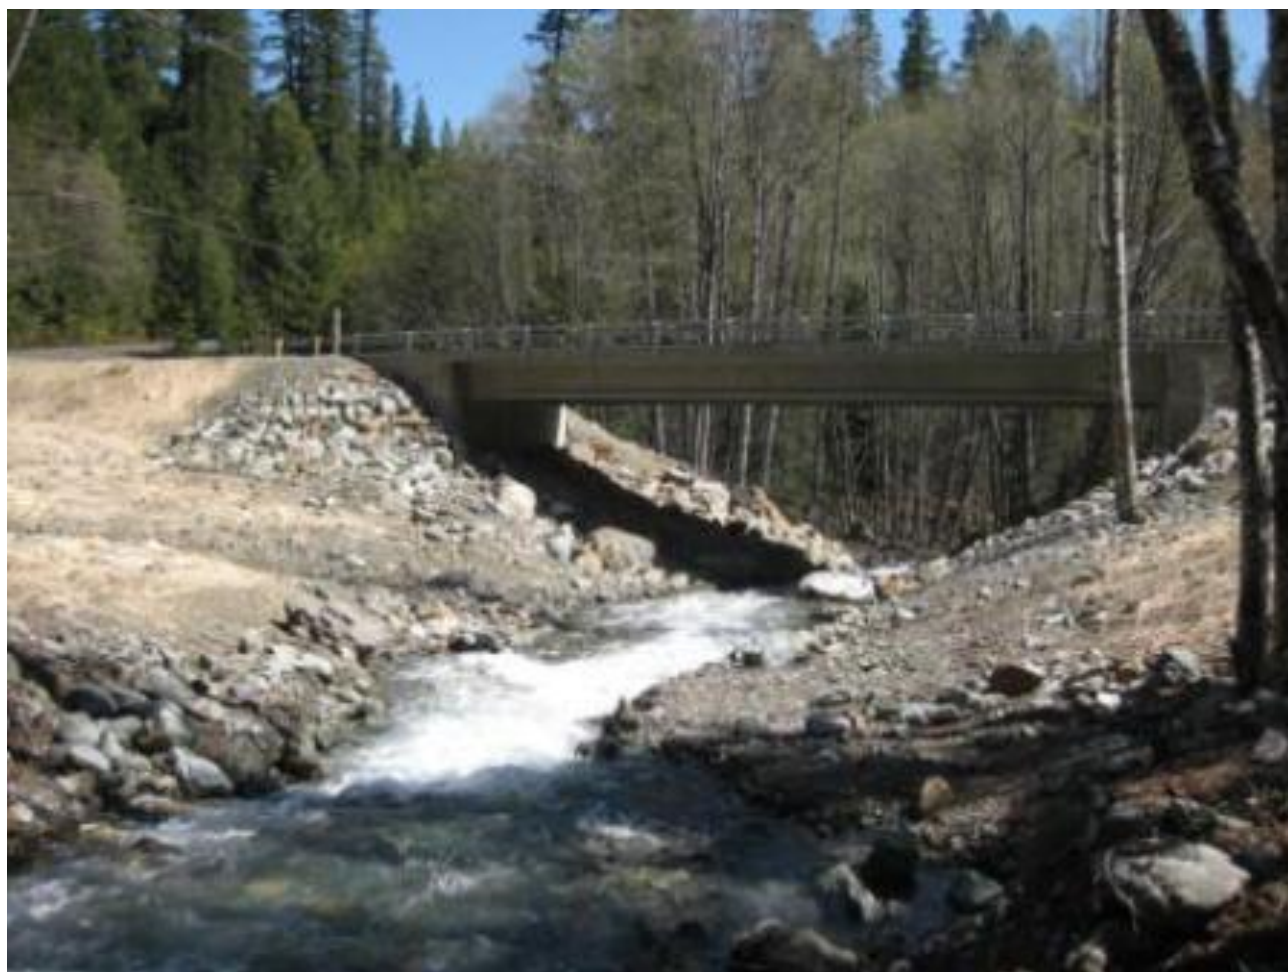
Figure 5. Upstream of construction site, disturbed site due to bypass in foreground.

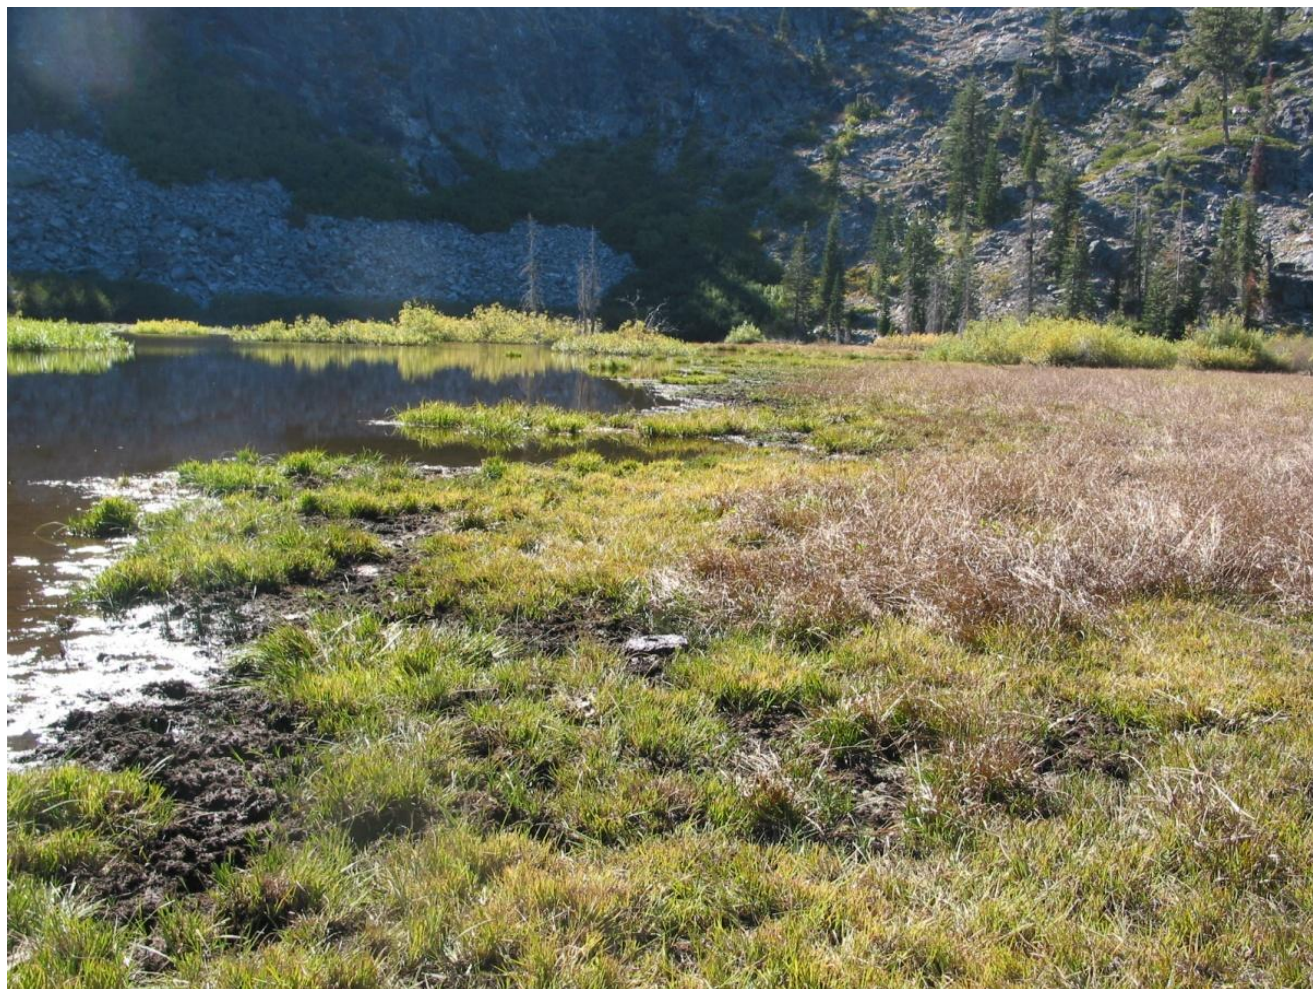
Two meadows were sampled in this meadow complex. One part of the meadow has a response channel running through the meadow while the other part of the meadow complex edges a small lake and has quite a bit of ponded water. When averaged, herbaceous utilization met >80% of the standard and guidelines. Woody utilization standards and guidelines were met. Woody riparian shrubs line over 60% of the stream reach. Some willow browse was observed but no alders were browsed. Effectiveness ratings were in the highest category except for bank stability, which was 73% stable along the stream reach and habitat disturbance, where <10 of the lentic habitat was effected by livestock hoof prints and trails (Figure 6). An average of 85% of this stream reach is shaded. Riparian shrubs are important in keeping the streambanks stable. Several cattle crossings and hoof shears were observed in openings along the creek bank. The lake by the meadow is receding due to a failing dam, which has left a lot of standing water. The meadow is changing rapidly and there are an abundance of young willows growing at the edge of the receding water. Some pond habitat has been altered (trails and soil exposed by hoof prints) by cattle as they move through the meadow.

Figure 6. Trampling next to pond in Meeks Meadow

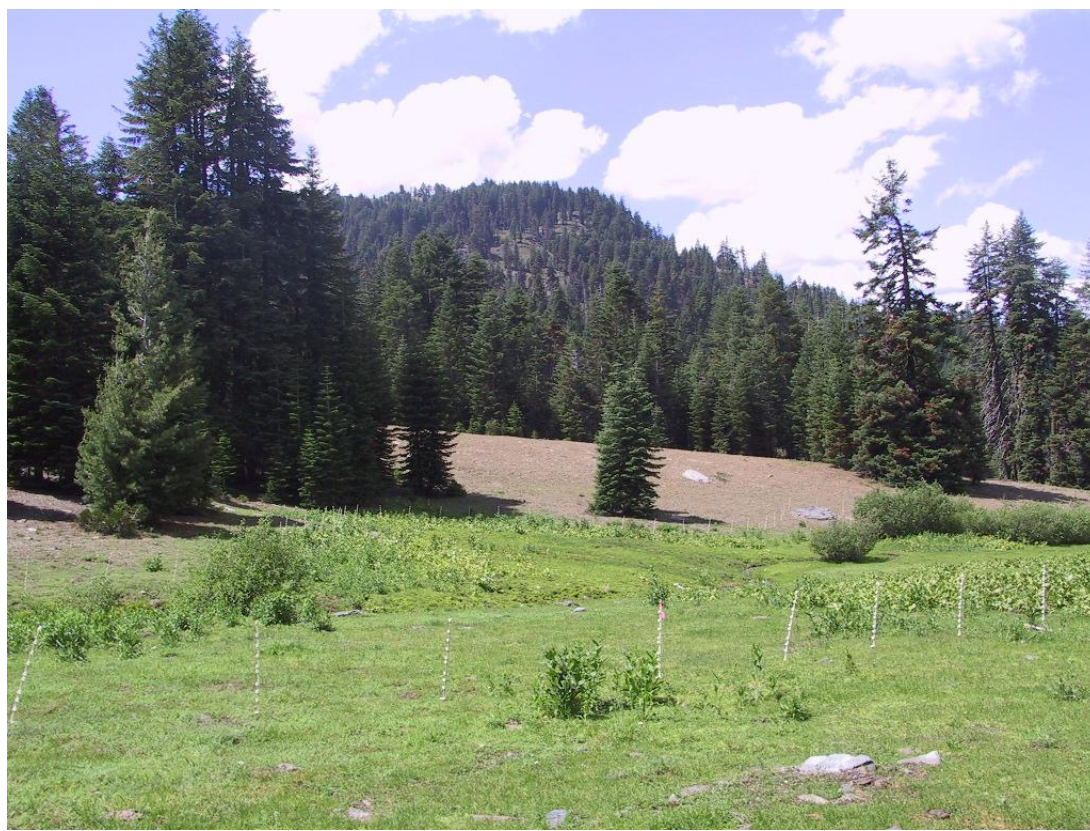
Figure 7. Electric fencing to protect creek banks during the early part of the grazing season.

Adaptive management has led to improvements in range management in 2010. On the sites that demonstrated bank instability in 2009, protective measures were applied. In one location electric fencing was placed along the site to keep cattle out during the early grazing season (Figure 7) and in the other location the permittee reduced the amount of time cattle spent at the site and utilization was kept under 40% (Figure 8). Multiple Indicator Monitoring (MIM) plots are also being installed on grazed streams on the Westside allotments so that condition and trend can be determined. Short term indicators including stubble height, browse, streambank alteration are measured annually on these plots and correlated to trend so that grazing standards may be refined and applied in order to protect water quality and riparian vegetation.

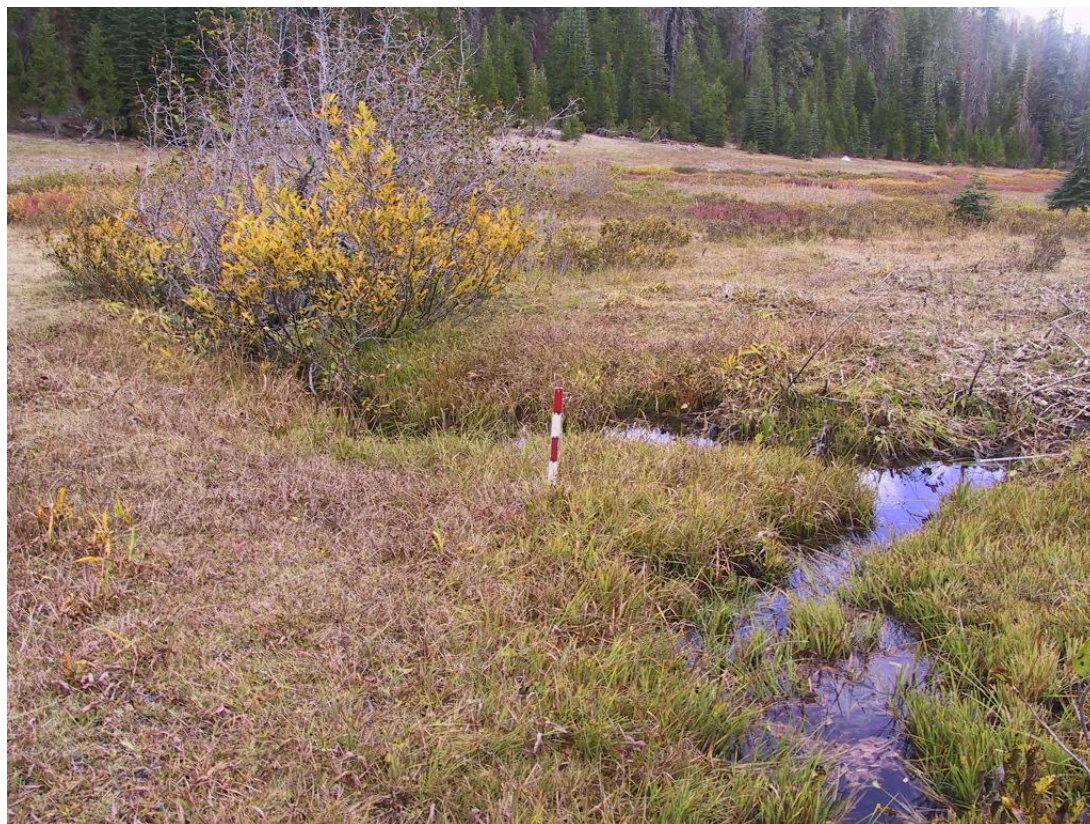
Figure 8. Less than 40% utilization at Hamilton Camp which reduced streambank trampling in 2010.
